A STUDY ON CORROSION DISTRESS IN KAMPLI BRIDGE

Dr. Narayan. G. Hebsur

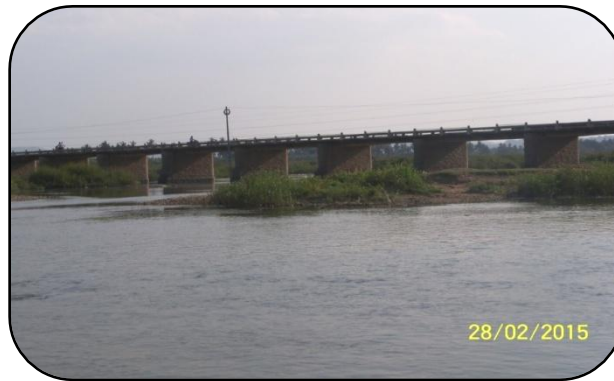
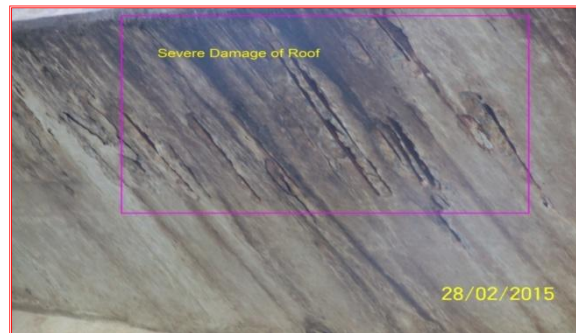
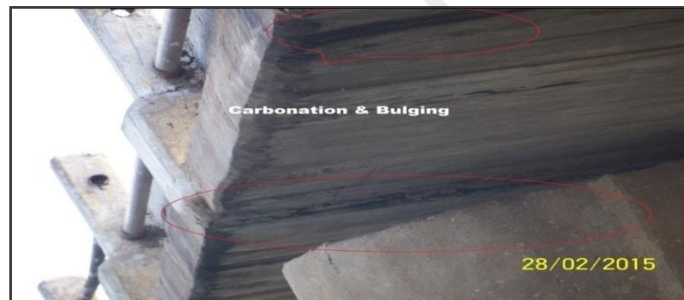
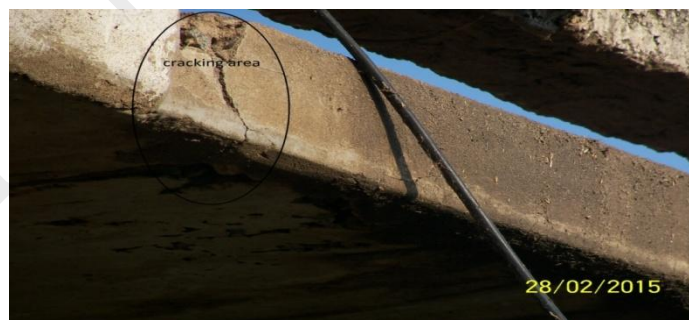
PHOTOGRAPHS:

- 1) In all inner face of roof slabs typical corrosion cracks have been observed. In number of slabs reinforcing bars are exposed to outer atmosphere. This indicates that, the process of corrosion might have initiated about 10-12 years back. The roof slabs, especially in middle and terminal are severely damaged. In some of the middle slabs the bars buckled out from the reinforcement frame work.

- 2) The process of carbonation in most of the slabs are observed along with heavy damp patches. The phenolphthalein indicator test in few selected areas substantiates the loss of alkalinity of the concrete suggest the acceleration of corrosion.

- 3) At the middle area on upper face of the roof big holes are formed due to collapse of concrete appears to be very dangerous. On road cracks can be observed.

- 4) Every year after rainy season the bracings of bridge damage severely/few collapsed completely as well and get repaired partially.
- 5) The highest damage can be observed in the wide stone masonry bridge columns. It is more predominant in columns located at the middle and also terminal columns of the bridge. Very wide cracks formed separating the stone framework can be commonly observed. In some of the columns prone to settlement, This is the most dangerous development, alarm that the bridge may collapse at any time.

- 6) In few slabs bulging of the core concrete is also noticed. This is harmful.
- 7) On Kampli bridge the movement of vehicles round the clock is regular and busy. Even though heavy vehicle transportation is banned the regular movement of buses & other moderately heavy vehicles can produce vibrations in roof.

The deteriorations are presented in photographs. All above observations prevails that, the Kampli bridge presents a severely damaged picture that resemble dilapidated and neglected structure. Even though few steps were taken such as minor repairs but they fail to protect the bridge for a long

1. The moderately affected inner roof slab area are marked and extent of corrosion is ensured. Then wash with water and the porous concrete is to be chipped off, If bars are exposed outside then the scales on them are removed and the bars are coated with zinc rich coatings are applied, On the affected area surroundings 2 mm holes are drilled. Further using high grade sulphate resistant cement(53 grade) concrete is to be prepared and with high pressure concrete is applied and the surface is made uniform.

2. The areas where cracks are wide chicken mesh is provided, The cracks are sealed by using surface sealants and concrete.
3. For the restoration of carbonation affected areas and concrete bulged cites, the loose concrete is chipped of and surface coatings are to be applied before covering.

4. At the middle of the bridge, alternatively a minimum of 10 supporting new columns with technically required design are to be constructed for strengthening.

5. Similar four new alternative terminal columns are to be provided.
6. Stone masonry columns are to be strengthened by standard methods.
7. The weak bracings are to be removed and reconstructed.
