THE USE OF THE ACRYLIC SEALANT IN THE EFFECTIVE TREATMENT OF RETRACTING FIXES IN STRUCTURAL MASONRY IN THE CITY OF MANAUS-AM. (BRAZIL)

KEY WORDS: Fissures, Acrylic Sealant, Pathology

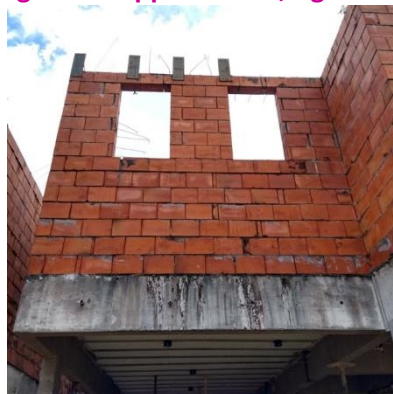
Figure 1 - Upper facade, right side

In the process of study and verification of the appearance of the anomalies, photo collections were created, but the part that stood out was the upper part of the facade because it was the area that caused the most visual discomfort. The house as already mentioned was all built in a ceramic block as shown in figures 1 and 2, after the laying of the masonry, the next step was the application of the slab and then finished with the plaster.

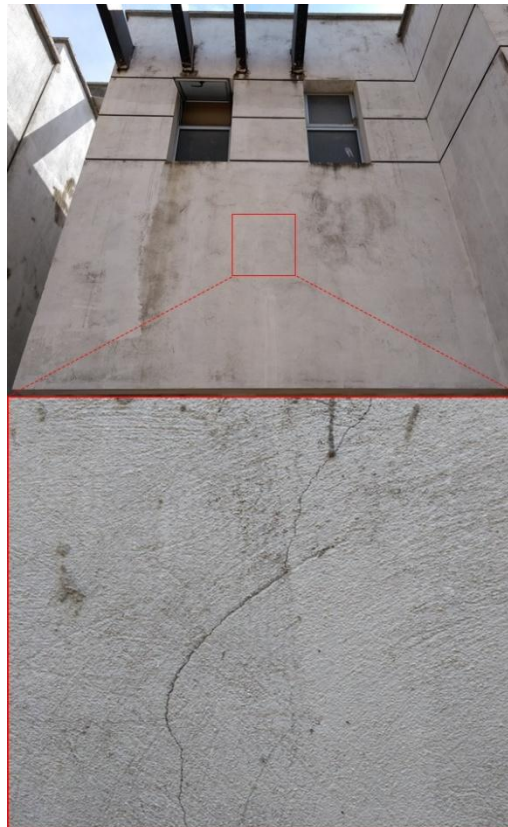
The appearance of the anomalies occurred approximately after 30 days, even between the cement mass cure process, after that period the possible causes of cracks were verified by the specialist specialized in pathologies, and the final diagnosis was retraction, process of reduction of volume that occurs in the mass due to the loss of excess water from the mixture by the evaporation process. Figures 3 and 4 show the appearance of the anomalies still in the initial phase.

Figure 3 – Upper facade after 30 days, at the beggining of the appearance of the cracks, right side

The white coloration occurs due to the application of a pigmented acrylic sealant shown in figure 5 which was used in an attempt to avoid a bigger problem due to climatic climatic conditions of the place, possibly causing possible infiltration of the structure.

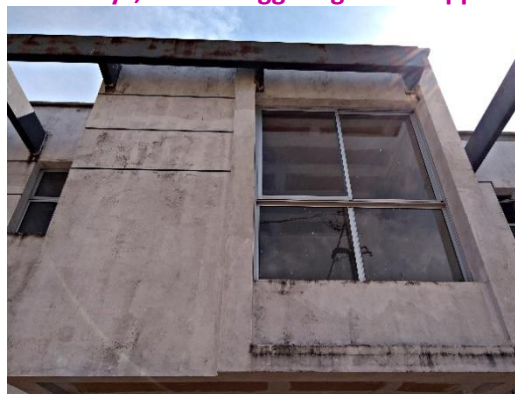
Figure 4 – Upper facade after 30 days, at the beggining of the appearance of the cracks, left side

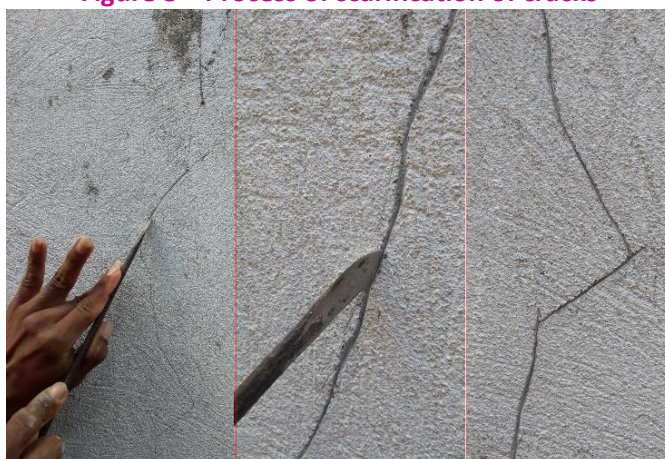
Figure 8 – Process of scarification of cracks

The first step is called fissure scarification, where a "V" shape risk is made about 3mm deep along the center of the anomaly, as shown in figure 8.

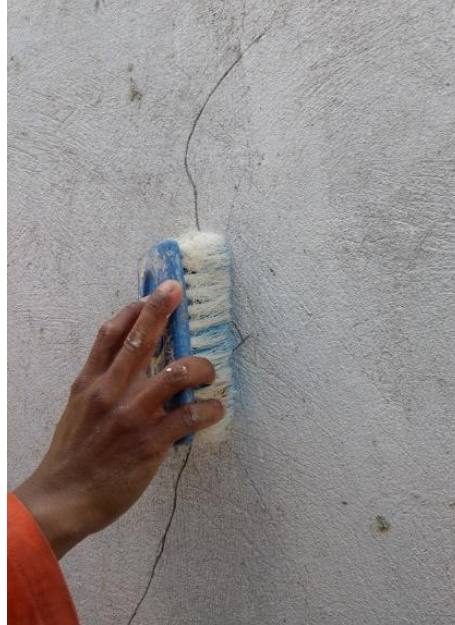
Figure 9 – Cleaning the scarification with a brush

The next step is cleaning the scarified surface, which with the help of the brush the task is executed both at the center of the hole and around it, as shown in figure 9. The purpose of cleaning is to avoid as much dust from entering the slot created, helping the acrylic sealant adhere to the site more accurately and efficiently.

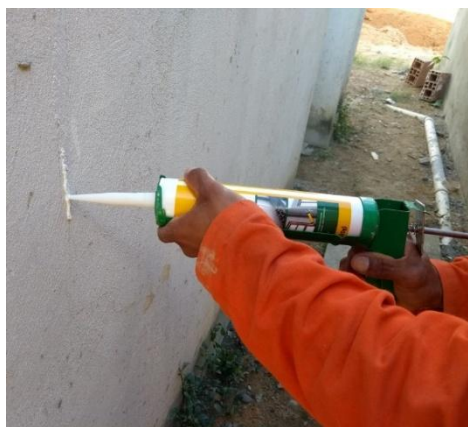
Figure 10 – Application of the product with the aid of a hand gun.

In the final step, where the product is applied in the already scarified fissure, a change in the method of performing the activity listed by the manufacturer on the product label has occurred. The manufacturer reports that the product should be applied with the aid of a hand gun used for the application of sealants as shown in figure 10, but it has been found that this method wastes a lot of time and material waste.

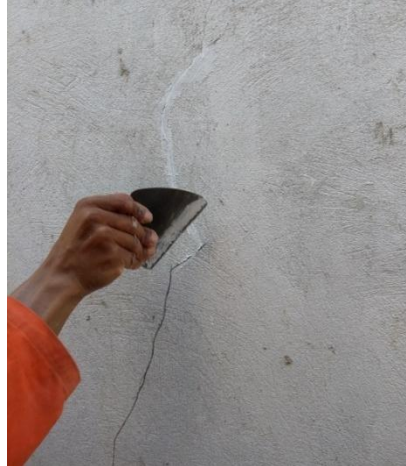
Figure 11 – Application of the product with the aid of the spatula

Then this process was replaced by the direct application of the sealant, depositing the product in the spatula and applying directly to the anomaly, it must be tightly tight against the sides of the crack to ensure a good adhesion, as shown in figure 11. This substitution in the execution of the service increased productivity and it was observed that the effect on the result was of excellence and satisfaction when compared to the previous method.

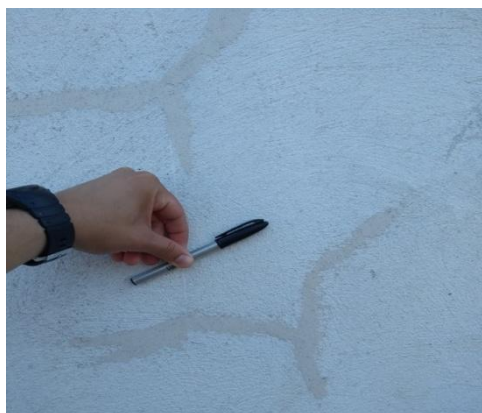
The result obtained through the observation made after the application of the acrylic product showed a satisfactory result, the manufacturer informs that the curing time of the material is approximately 24 hours, but for greater safety in efficacy, the expected time after the application is executed until the sanding process and regularization of the site to the next stage of painting through pigmented texture was approximately 48 hours. Figure 12 shows the analysis of the treatment after waiting.

Figure 12 - Sample of cracks treated after 48 hours

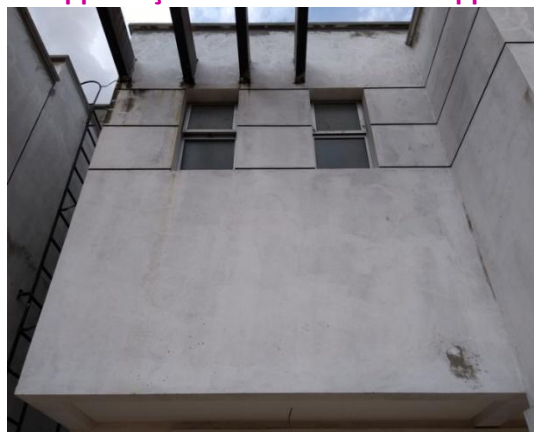
After a thorough observation and verification of the regularization of the masonry, it was observed that the place was able to receive the final step of the coating that in the case of this enterprise was used Acrylic Pigmented Texture. Attention must also be paid to the care after application of the material, in which case the curing time has been free from rain or any contact with water at the site of the anomalies. In photos 13 and 14 it is possible to observe the view of the upper façade 48 hours after the treatment.

Figure 13 - View of the upper façade 48 hours after the applied product, direct side

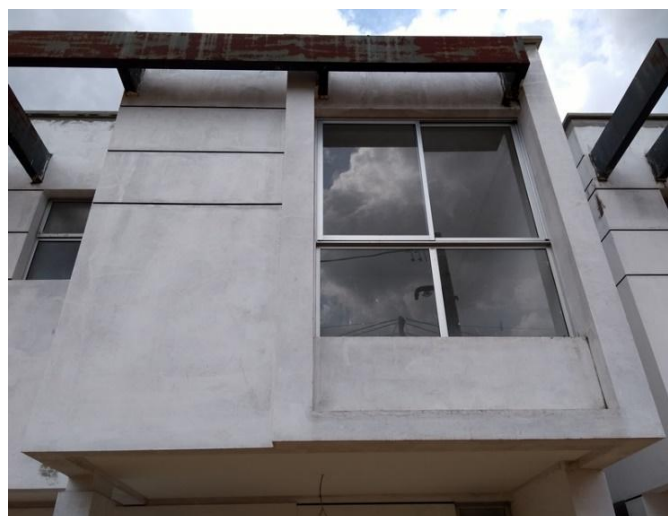
Figure 14 – View of the upper facade 48 hours after the product applied, left side

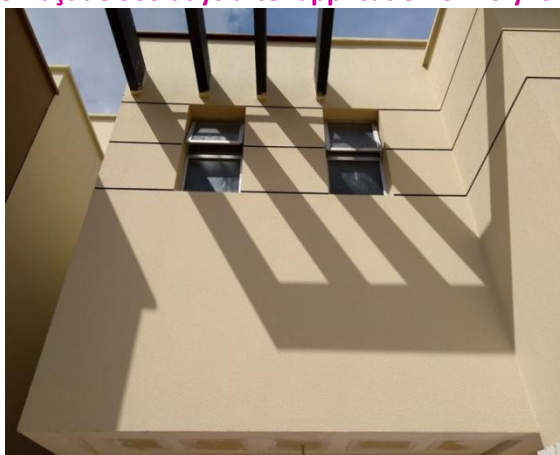
After receiving a last coat of Hipercor acrylic sealant, the pigmented texture was applied after 72 hours and thus began a careful observation of the site every 30 days, during which time a collaborator was destined to perform the monthly inspection with the intuition to verify the behavior of the structure at the treatment site. At the end of the 10th month observed, the last month before the delivery of the property was observed a total efficiency of the product because the anomalies did not persist as shown in figures 14 and 15 proving that the method studied was a great investment option.

Figure 15 – View of the upper façade 300 days after application of Acrylic Pigmented Texture, left side

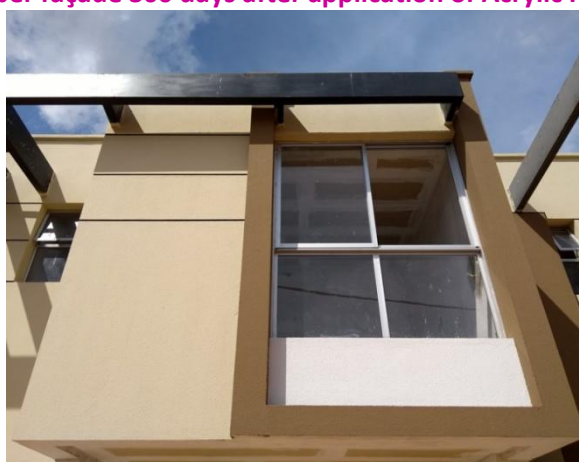
Figure 16 – View of the upper façade 300 days after application of Acrylic Pigmented Texture, left side
