THE USE OF THE ACRYLIC SEALANT IN THE EFFECTIVE TREATMENT OF RETRACTING FIXES IN STRUCTURAL MASONRY IN THE CITY OF MANAUS-AM. (BRAZIL)

KEY WORDS: Fissures, Acrylic Sealant, Pathology

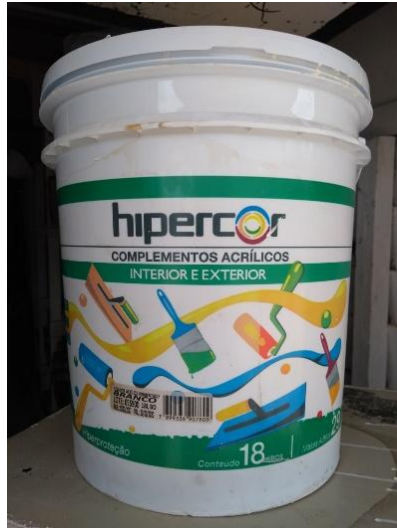
The white coloration occurs due to the application of a pigmented acrylic sealant shown in figure 5 which was used in an attempt to avoid a bigger problem due to climatic climatic conditions of the place, possibly causing possible infiltration of the structure.

Figure 5 – White acrylic sealer

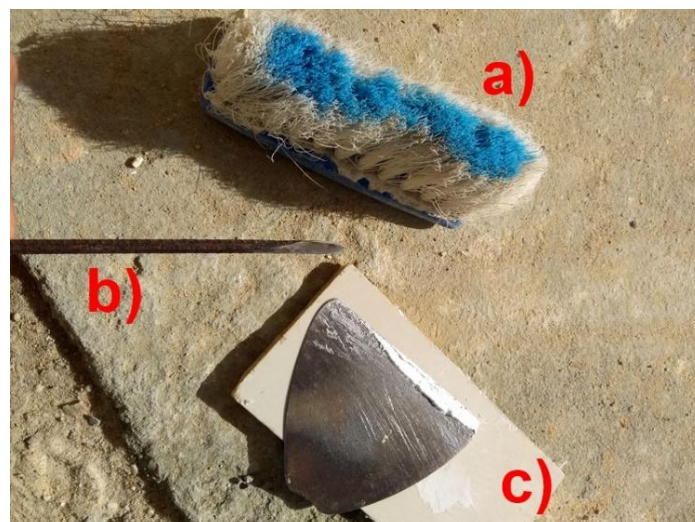
The materials used for the use of this method were based on the information and instructions of the manufacturer informed on the product label. Figure 6 shows three fundamental tools for the process to be done correctly, they are: a) Bristle with soft bristles; b) 30 cm CA50, 5/16 "rebar with sharp tip; c) Stainless steel spatula used for regularization.

Figure 6 - Tools used to apply the product

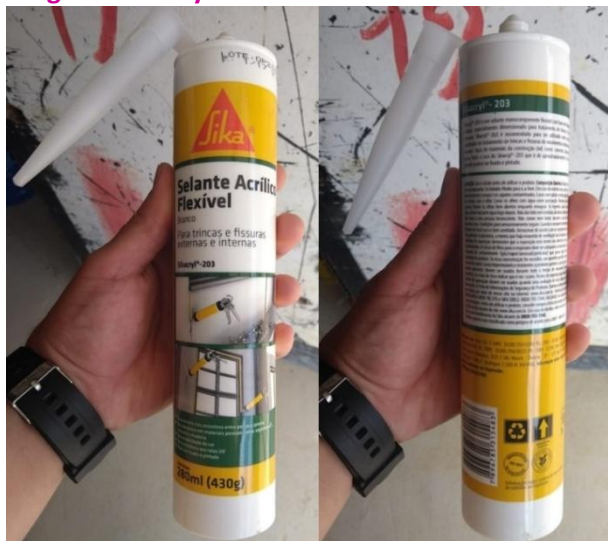
In this research was used the Sealant of the brand Sika - Acrylic Flexible Sealant, in the white color indicated for cracks and external and internal cracks (Figure 7). The option for this product is justified because it is the cheapest material found after market research carried out in the city of Manaus.

Figure 7 – Acrylic Sealant selected for research
